INNOVATIVE GREEN TECHNOLOGY

TOG TelferTech "TOG" System

TelferTech “TOG” System

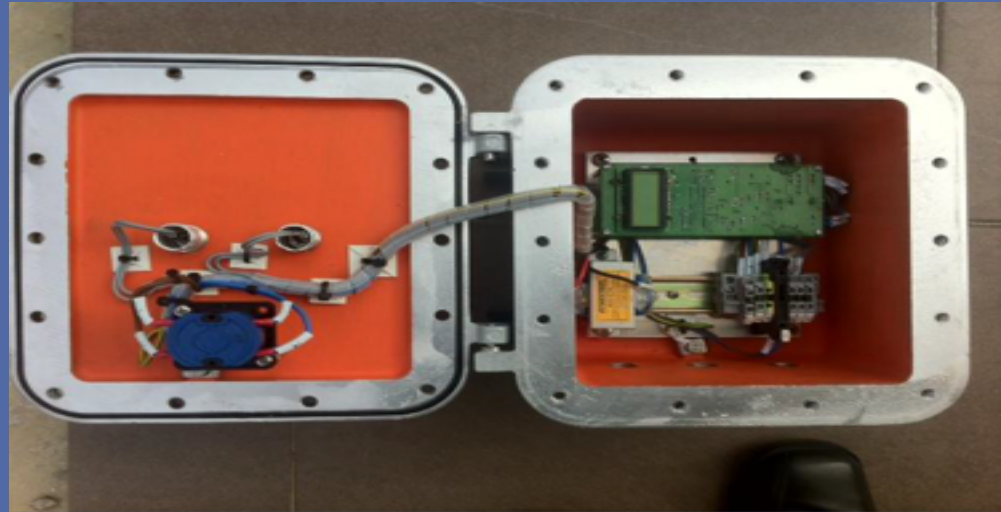
"TOG" – Control Unit

Powered by a low voltage power pack, AC 10 VOLT 1 AMP. Houses a circuit board incorporating a pre-programmed microchip to transmit more than 10 million sets of sonic waves to the activators.

The sound emission generated creates Sweeping Sound Frequencies (SSF) pattern which are then transmitted to the area of treatment via the activators.

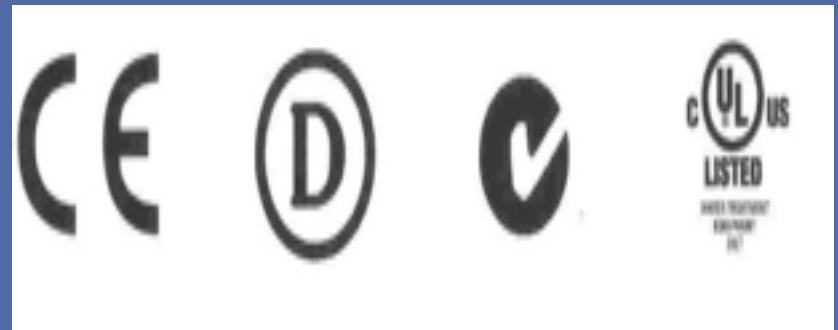
Compliance - Sound

All TelferTech “TOG” System has been tested and complied with all regulatory sound emission laws and electrical compliance approvals.

- ❖ C Tick compliance
- ❖ UL compliance
- ❖ CE compliance
- ❖ D Mark compliance

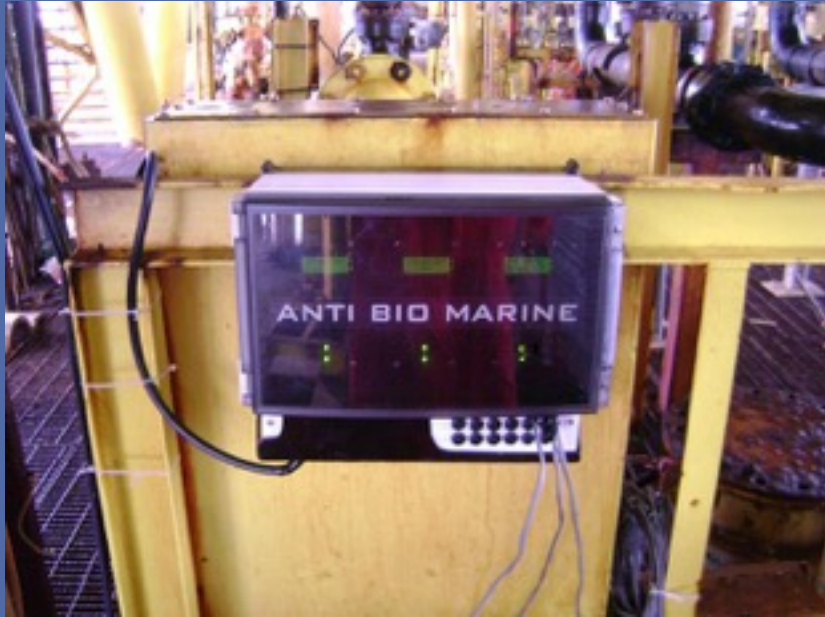
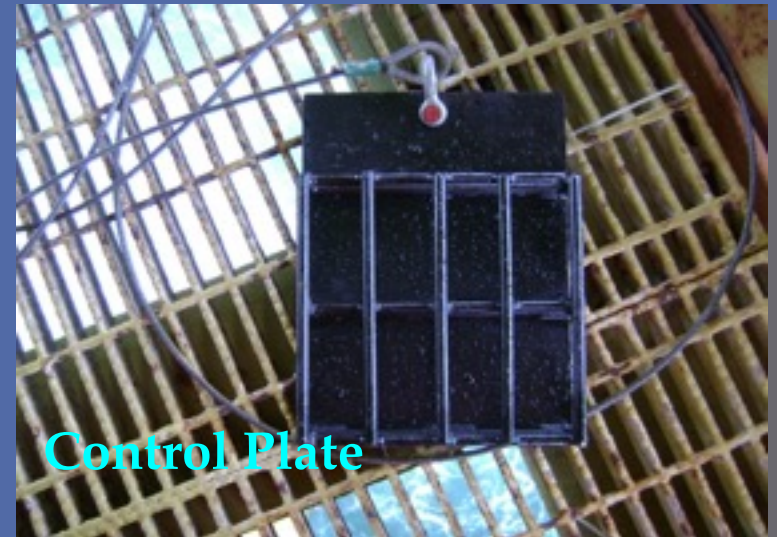
Steel Plate Validation – equipment setup

Two 12" x 8" carbon steel plate - one Controlled, one Test were positioned 3 meters below water surface on February 2nd, 2009 for monitoring purposes.

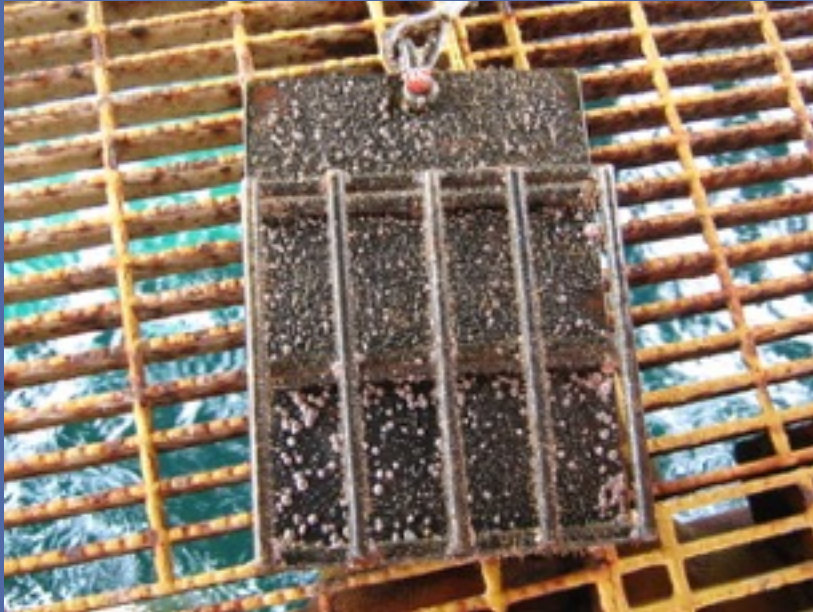
Control Plate

Evidence of beginning growth of baby barnacles, barnacle colonization begin to develop on both Plates.

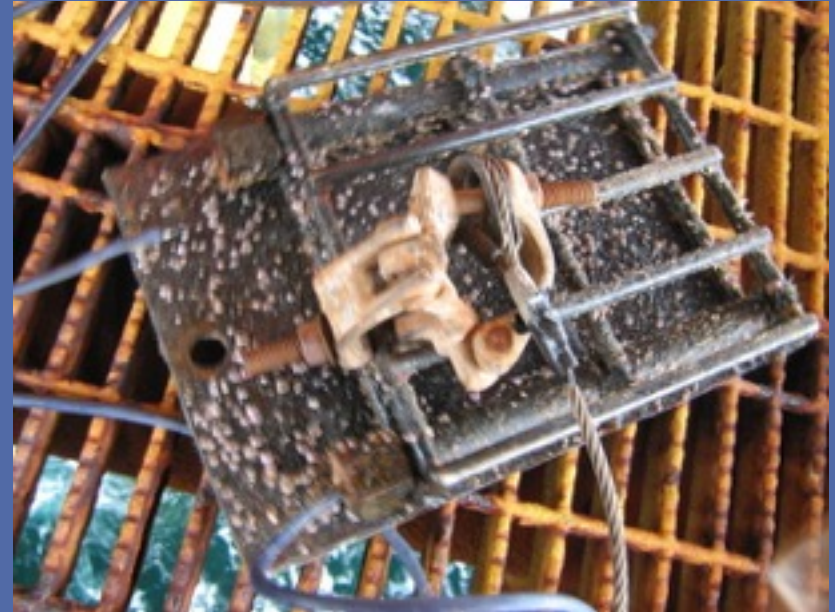
Test Plate – with Activators –
power cable broken.

Test Plate's electrical wire broken, water gets into activator shield, triggered reverse effect. Engineers on-site do good the wires, activators & shields.

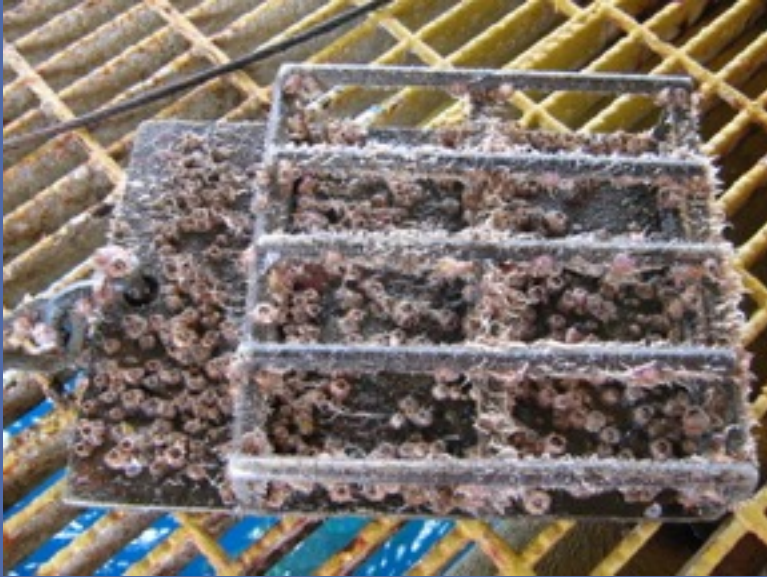
Baby barnacles on Control Plate are getting matured and growing into colonies.

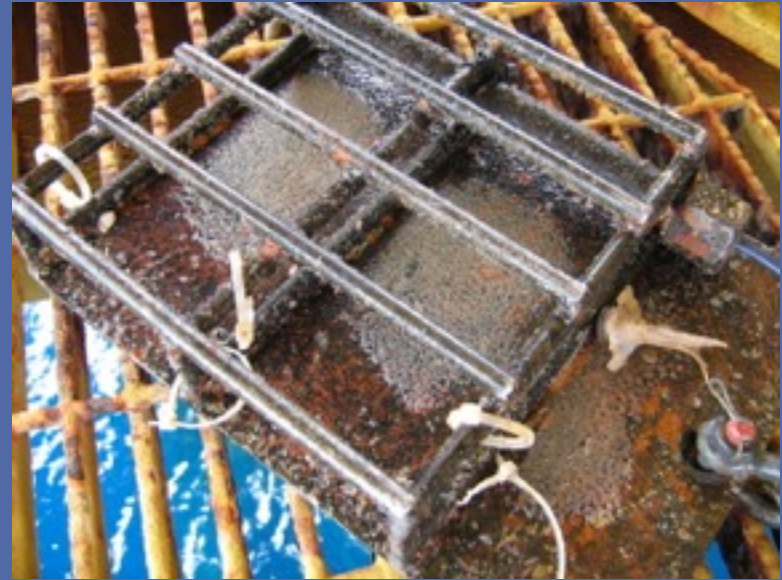
Baby barnacles on Test Plate from 1st inspection has fallen off and no further growth was observed.

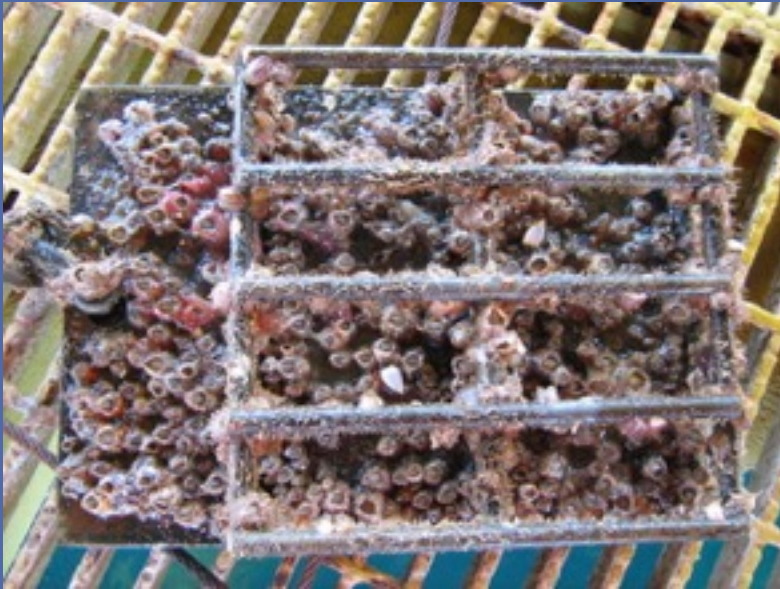
Colonies on Control Plate are getting more matured and dense.

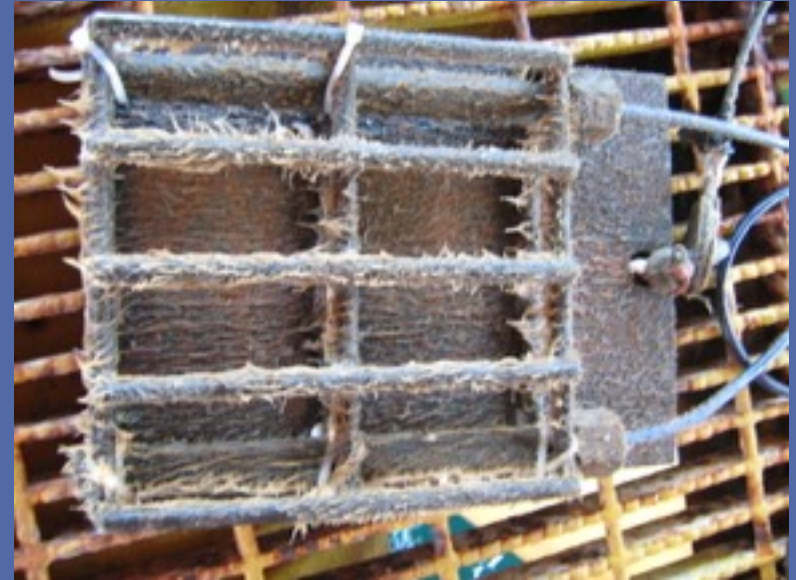
Test Plate still CLEAN except minor biological growth which is normal under the sea.

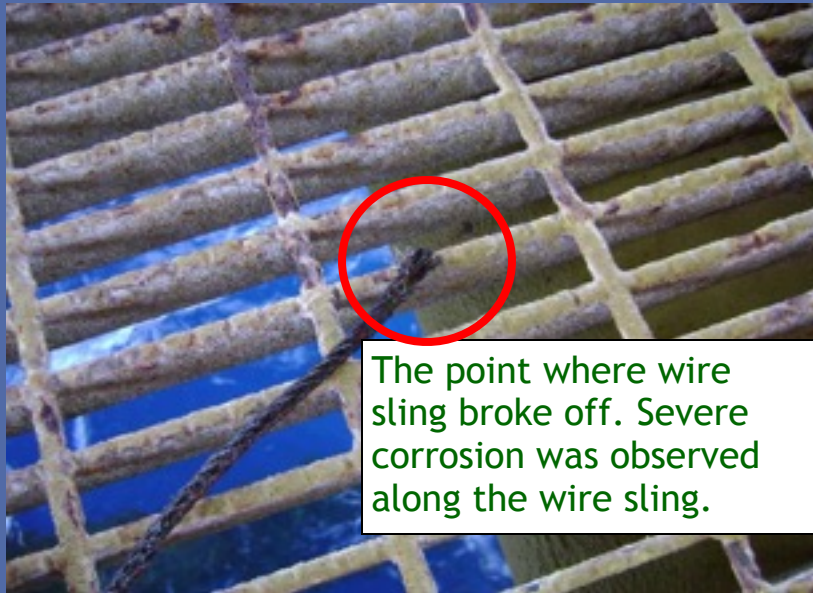
The point where wire sling broke off. Severe corrosion was observed along the wire sling.

Stainless steel sling holding Control Plate was broken due to corrosion, load and expanded surface area. Control Plate has lost in the ocean that's unfortunate.

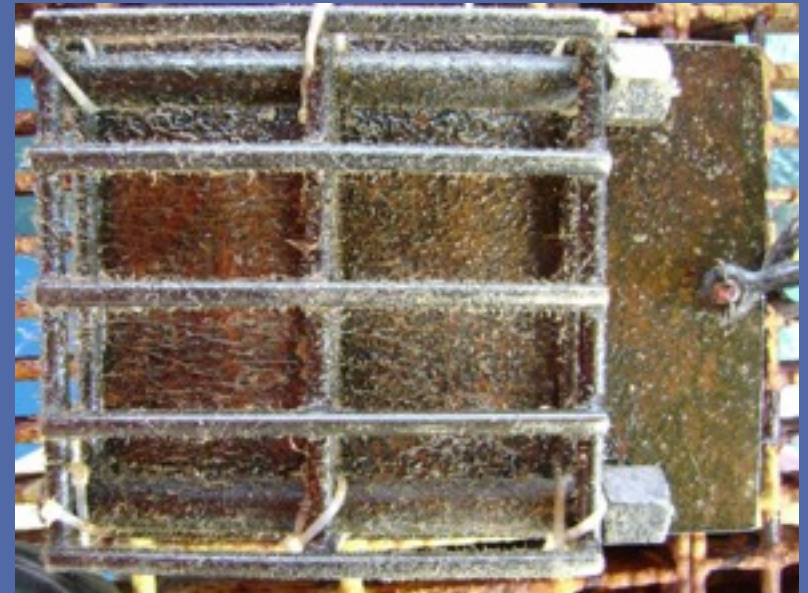
Fortunately Test Plate was still intact and was observed the Plate is still CLEAN.

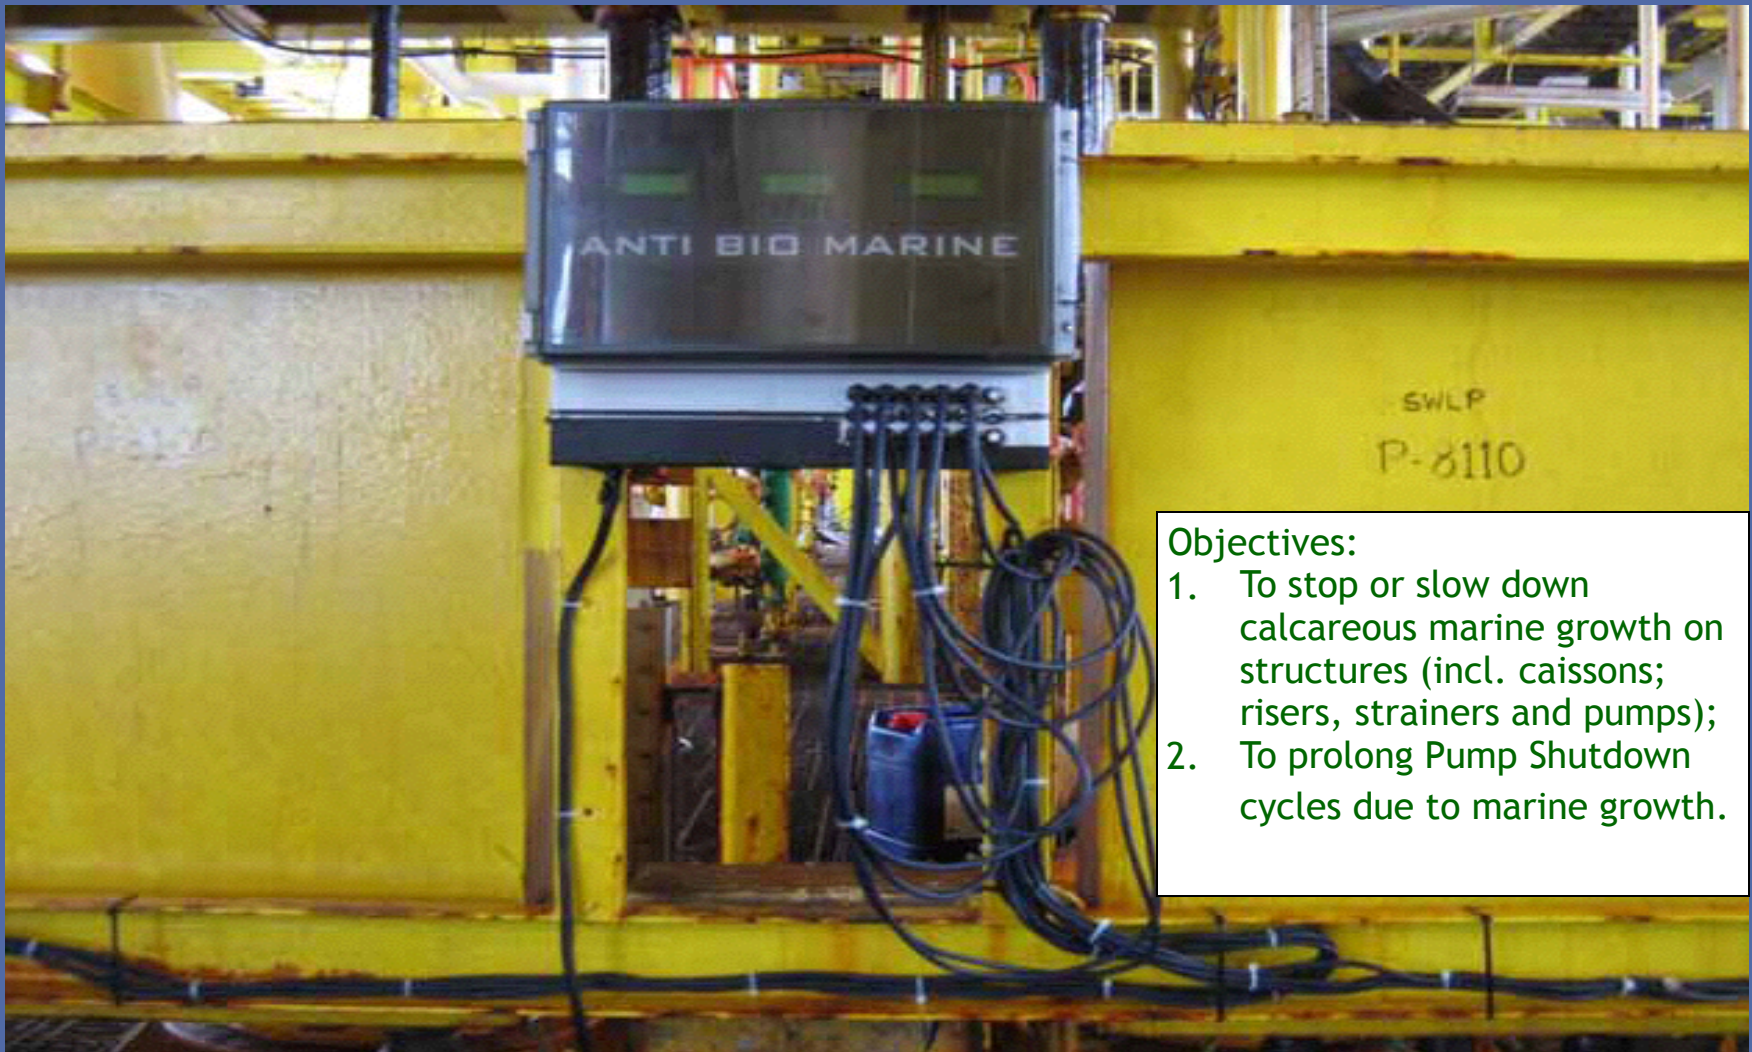
Two sea water lifting pumps (SWLP) were "treated" by TOG
Each caisson with 5 Activators

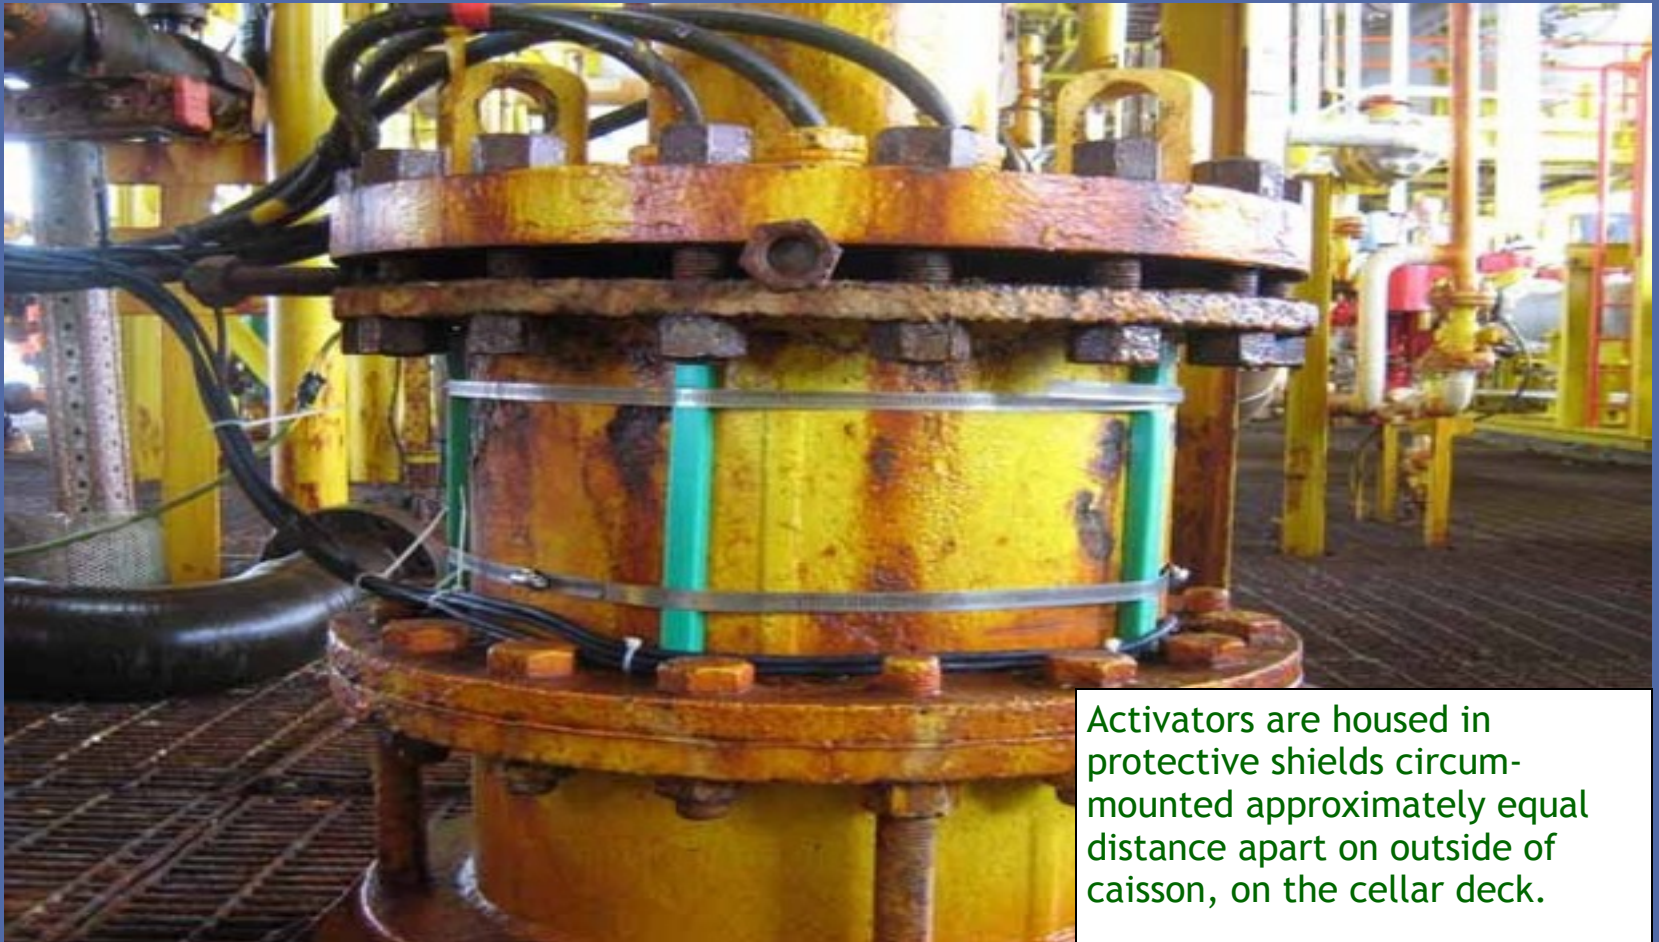
Live Structure - SWLP

Activators are housed in protective shields circum-mounted approximately equal distance apart on outside of caisson, on the cellar deck.

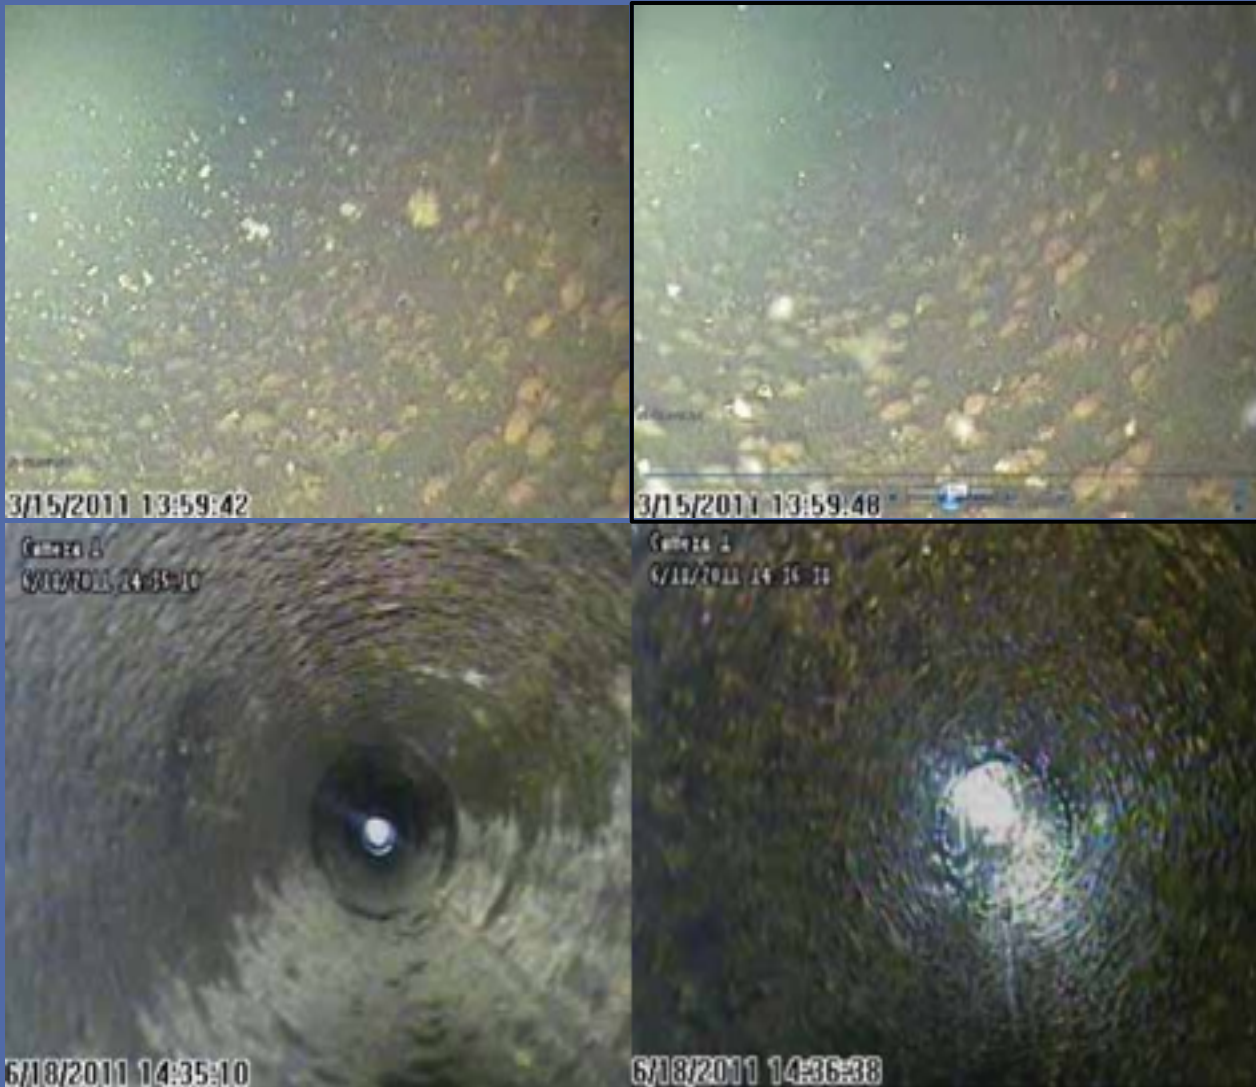
Monitoring Pictures

No evidence of continued growth of barnacles from March 2011 to June 2011 with **TOG** installed.

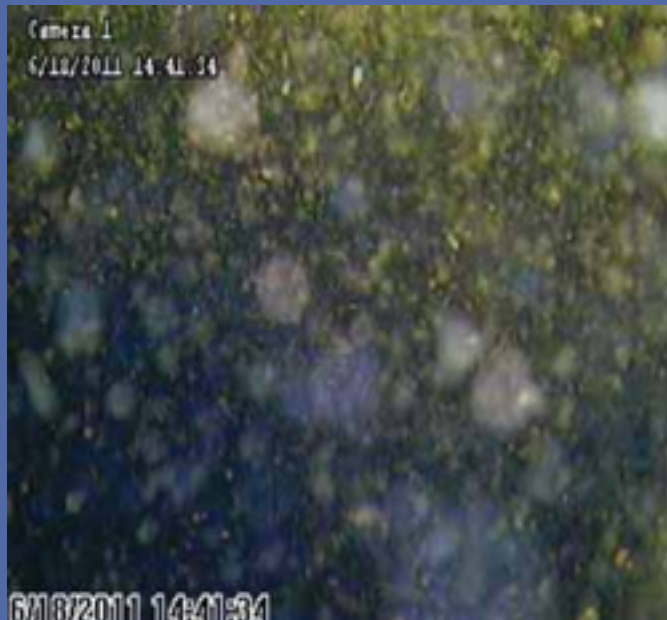
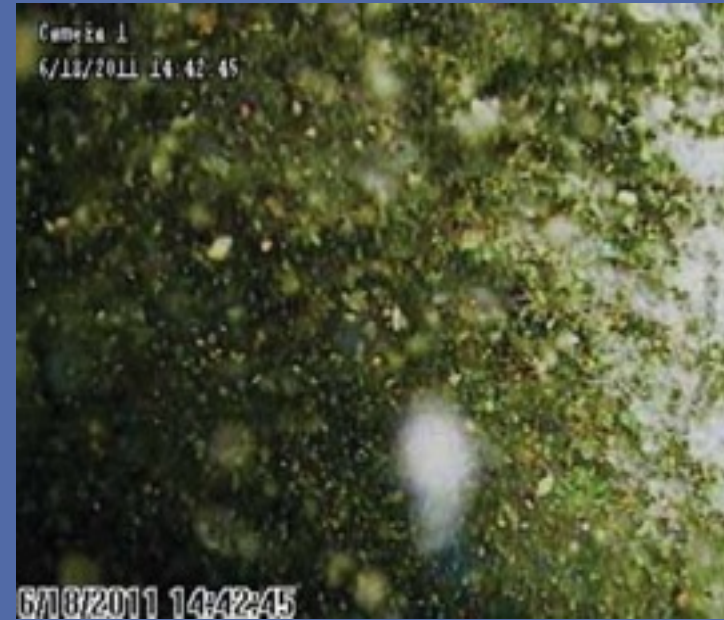
Monitoring – Unique Phenomena

Abundance of “loose particles” floating in the water column believed was from detachment of “existing growth” and particles in water that are not able to attach to substrates.

A “phenomenon” that was never seen before in the long history of the platform, commented by platform engineers.

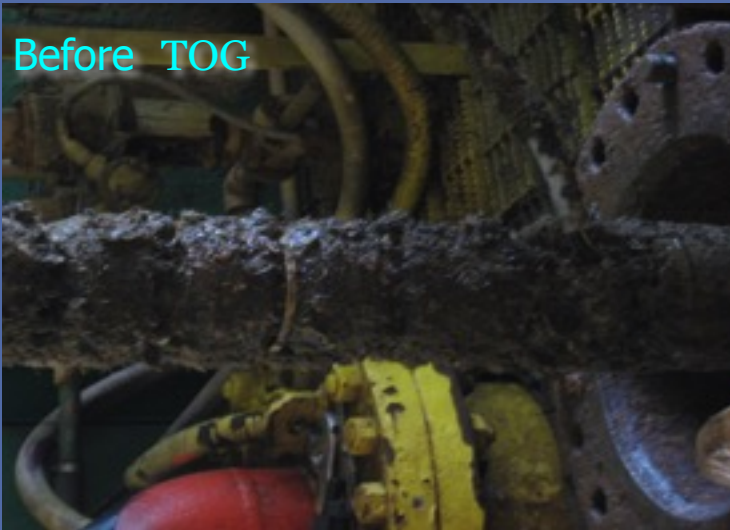
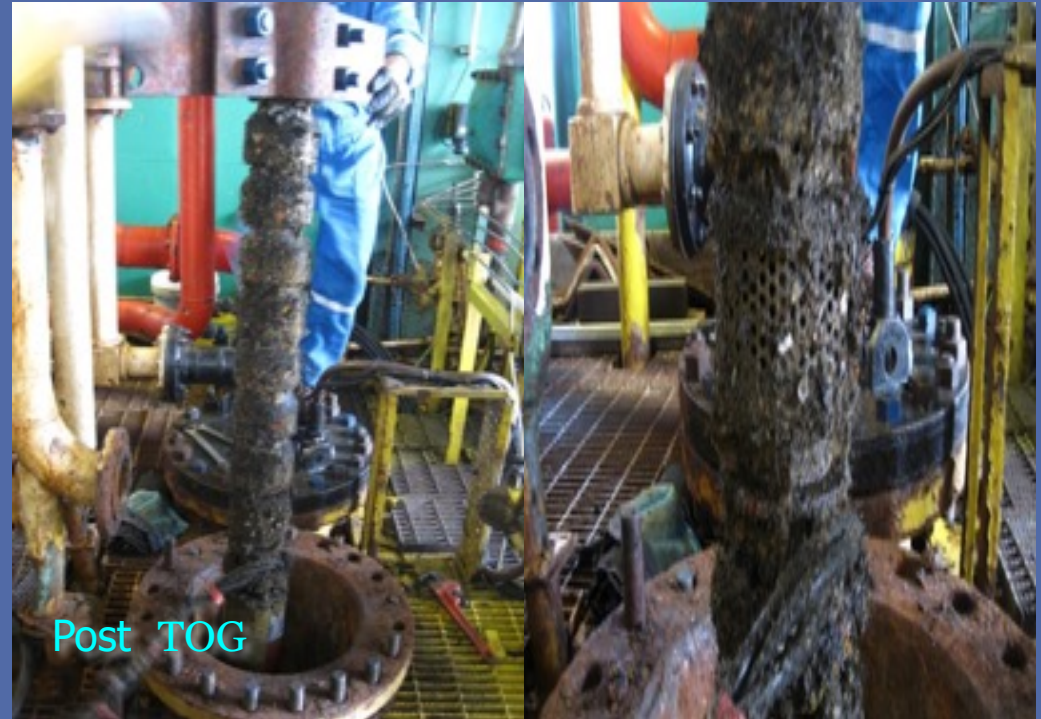
Monitoring – Another Phenomena

Most parts of the Strainer are visible, loose patches of slimy biological growth falls off easily by just running finger over

No evidence of calcareous growth after TOG installed

Before TOG – high powered jet was used to ‘remove’ rock-solid calcareous growth on the Riser

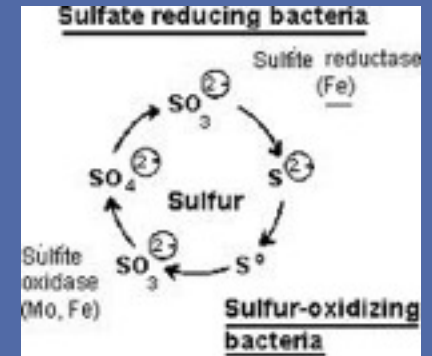
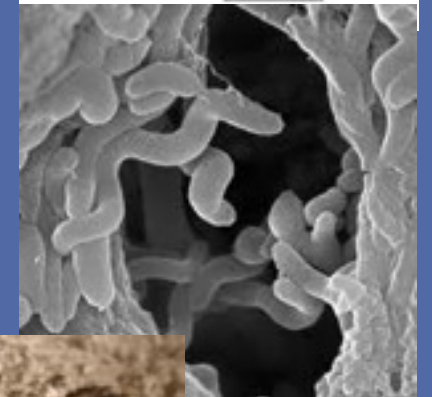
Pre TOG – Confirmed etching marks of SRB on Impellers

Post TOG – NO signs of SRB etching marks on Impellers

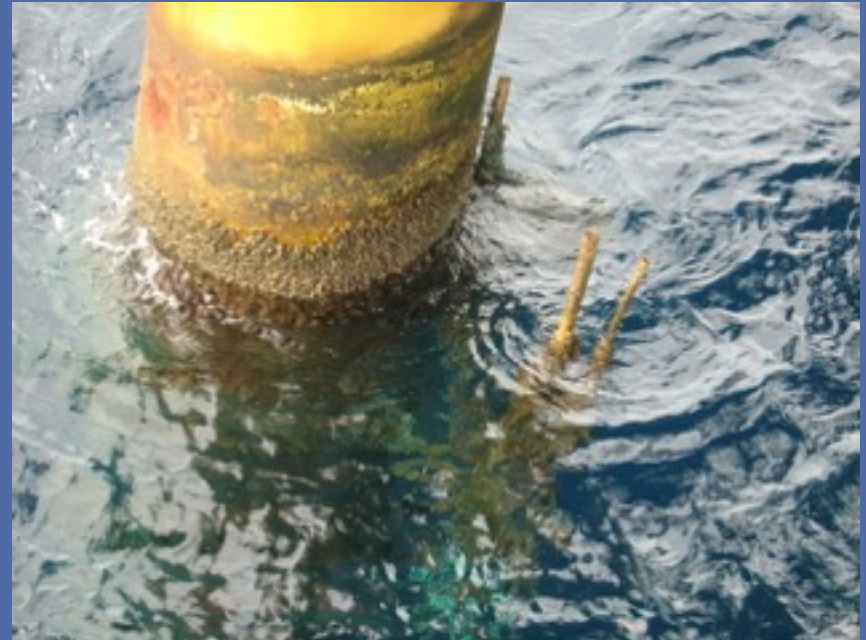
Offshore Platforms

1. Pump Caissons
2. Conductors
3. Boat Landings
4. Jacket Legs
5. VDMs and
6. Horizontal Braces
down to 2nd Bracing Level

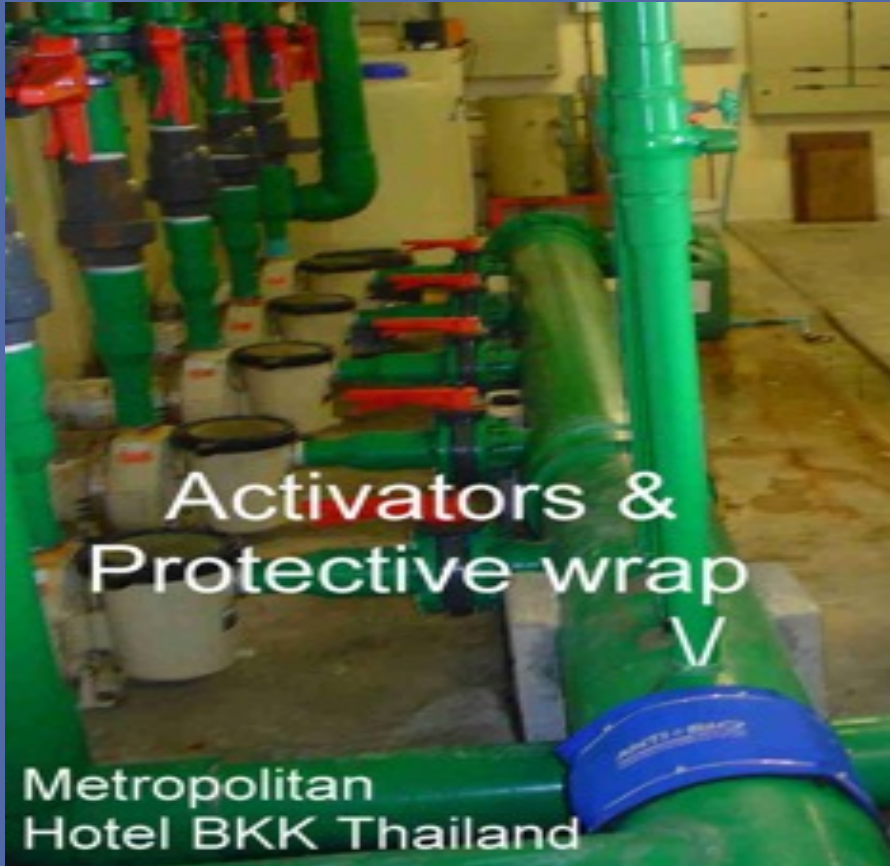
Water Treatment – TWM

Activators are on the outside of pipe work near the filtration system

No part of the system touches the water

1. Effectively removes biofilm
2. Improves filtration efficiency
3. Prolongs filter media lifespan
4. Help to balance pH
5. Significantly reduces chemical usage
6. Mitigate scale formation
7. Improves water quality
8. Reduces backwash cycle frequency & backwashing time – saving on water & chemical
9. Lowering overall operating and maintenance expenditures
